**Short desktop assessment of the farmstead situated on  
Portion 1 of the farm Bellevue 15321, Pietermaritzburg**

Prepared for:  
Archaeological Tourism & Resource Management  
PO Box 102532, Meerensee, KwaZulu-Natal 3901  
November 2010

## Introduction and methodology:

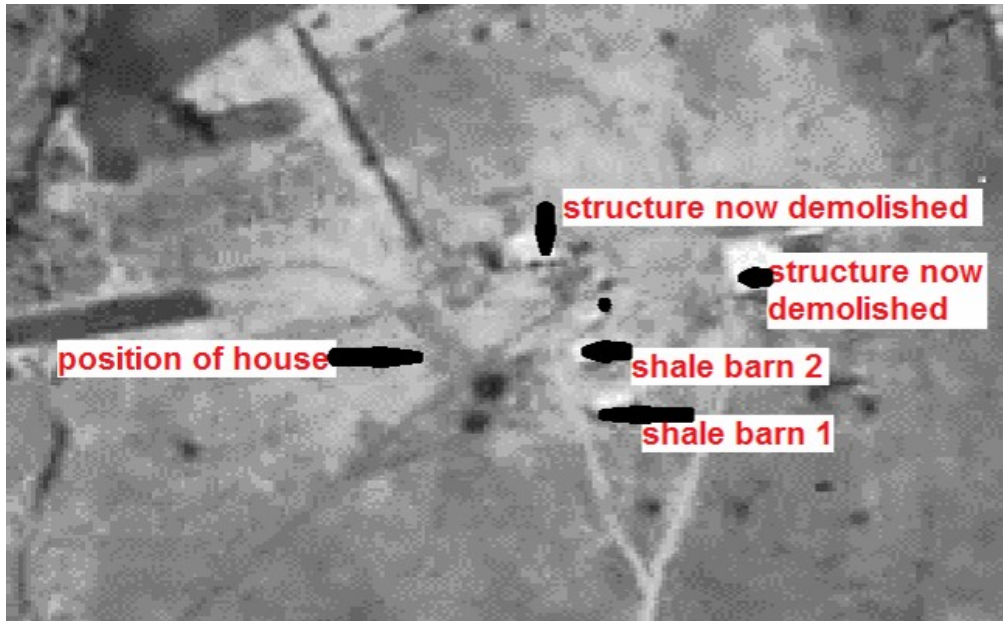
**Fig 2: 1937 aerial photograph showing the barns and two demolished structures**

The 1937 aerial photos are diagnostically uncertain, but the two barns appear to be extant. There is no sign at this photographic resolution as to the presence of the silos, and it is suspected that these were constructed at a later date. The two silos are positioned between the barns.

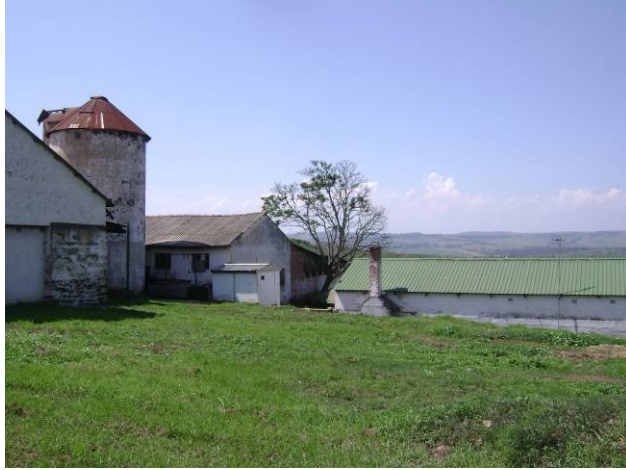
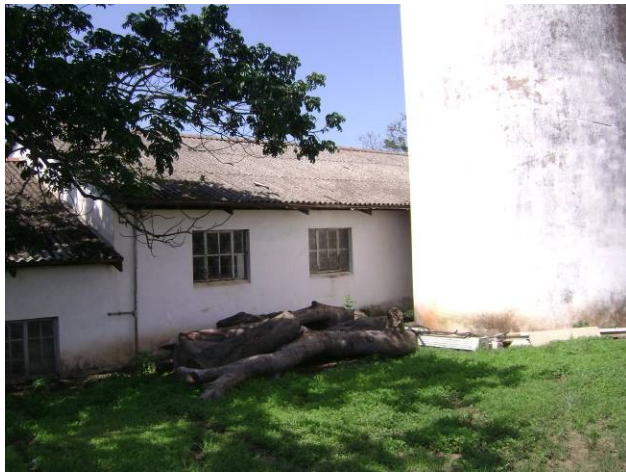
Both of the barns are of mixed, though largely shale construction which situates them as vernacular buildings located any time between the middle years of the 19<sup>th</sup> century and 1937 when they are present on the photographs. Barn no 2 has been extended more recently to the north-west. The roof sheeting is old, and there is little diagnostic marking on the underside of the sheeting. However, the space between the barns was roofed in more recent times. Apertures below wall-plate level have been filled in with brick at some time.

In addition, an important feature of the site is the two silos. They form part of the architectural massing of the barns and create a topophilia on the site. For travellers along the N3, this farmstead is characterised by the barns and the silos, and forms a landmark along the road.

***Figs 5 and 6: Showing grouping of silos, barns 1 and 2 and brick barn, and extended portion of barn no 1 with silo in foreground***

**RECOMMENDATIONS:** *Given the age and scale of the shale barns it is recommended that these structures, together with the silos be reused in the new development. Since the brick barn is likely of an age, and part of an architectural grouping, its contribution to the topophilia of the site indicates that it too, should be retained and reused.*

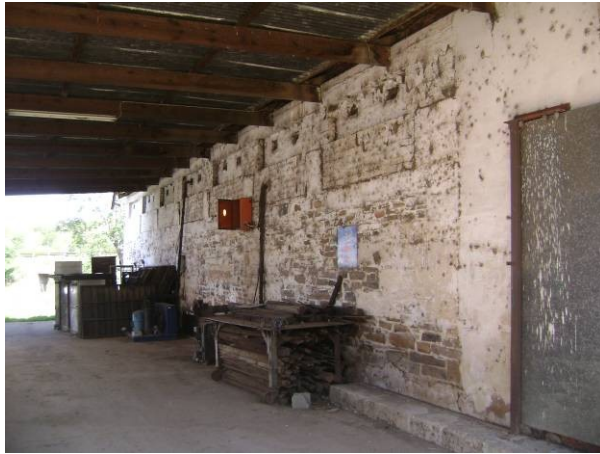
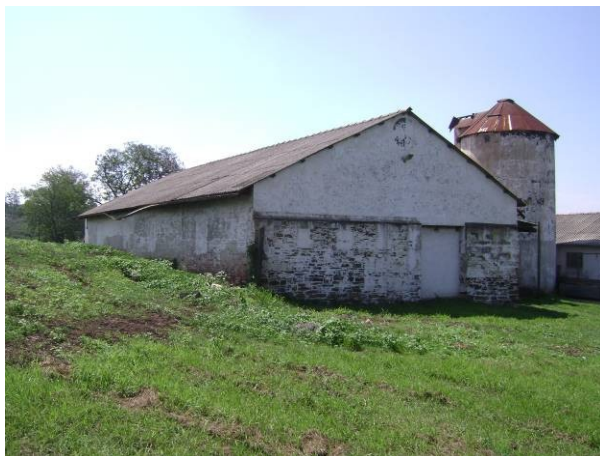
**Figs 5 and 6: The covered space between shale barns and Barn no 1 with a silo behind**

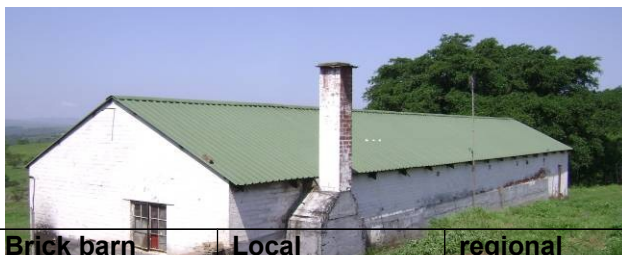
This structure is of painted brickwork in English bond under a corrugated sheeting roof. It is suspected that it dates to pre-1950. It forms part of a group together with the shale barns. It has certainly been extended to the north-west since its original construction.

**Figs 7 and 8: Showing the old brick barn: the portion towards the trees is in English bond suggesting that this portion was pre- or immediately post- World War II.**

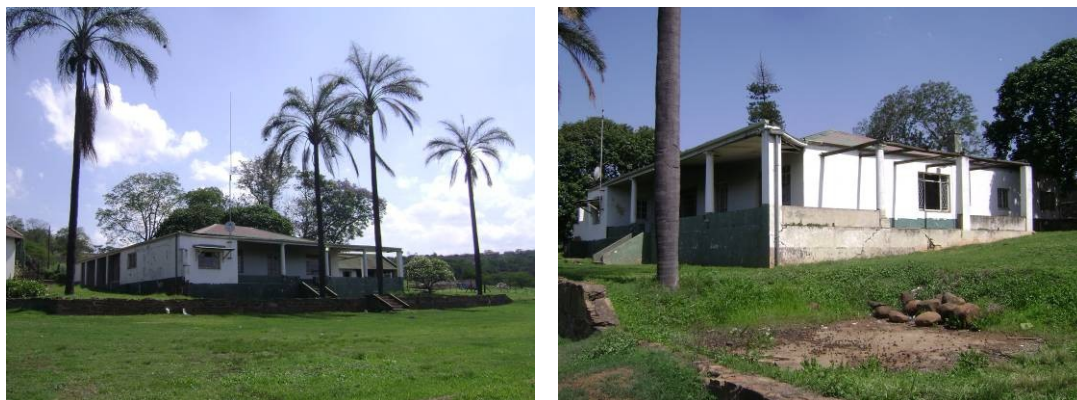
It is of conventional construction under a low pitched corrugated sheeting roof. The windows are mainly stock steel items and there is little evidence of these being changed, suggesting that they are largely original windows. The floors are parquet, and the ceiling painted strip timber. There is an extensive veranda to the north and the west which is a state of disrepair. Simple pre-cast Tuscan columns support the veranda roof.

The house does not feature on the 1937 aerial photograph. It is suspected that it could have been constructed by the Ferguson family in either 1943 or later in 1965. It is currently unoccupied and needs much work for full rehabilitation. It is removed from the group of barns and has little relation to them.

**Figs 9 and 10:** *The main house at Bellevue from the north-east and from the north-west*

**RECOMMENDATIONS:** *Given the dislocation from the farmstead, the lack of association with buildings of landmark, and its minimal architectural, social or historical merit, it is suggested the demolition of this building could be considered an option.*

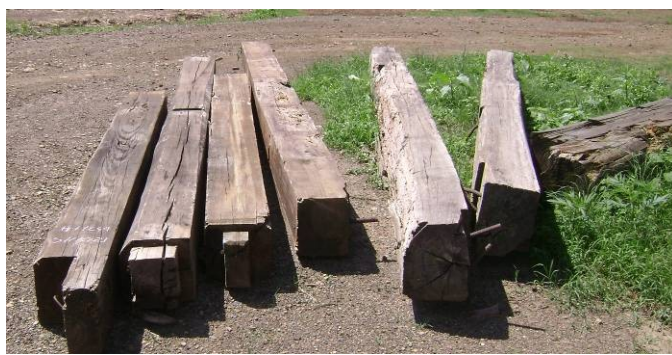
***There is a pile of substantial timber beams***

***suspected to originate from the farmstead lying next to the barns. It is recommended that these be donated to the Amafa Materials Bank for reuse in historic structures in need.***
