# The Oslo Opera House – Condition Analysis and Proposal for Cleaning, Protection and Maintenance of Exterior Marble

**Keywords:** Oslo Opera House · Yellowing identification · Cleaning with nanogels

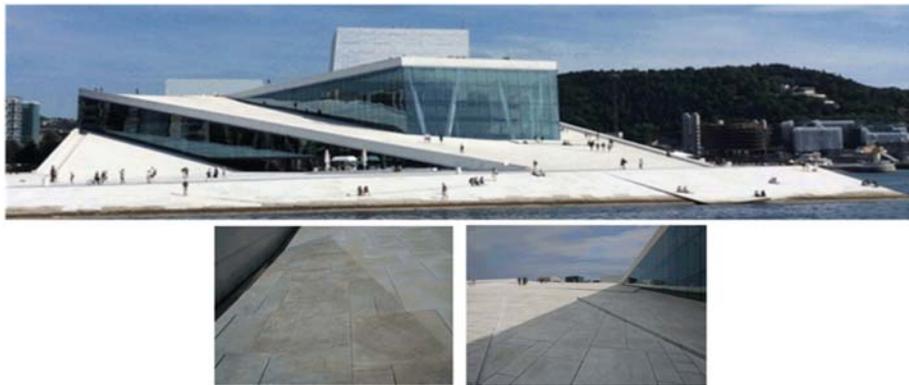
**Fig. 1.** Yellowing observed in the cladded façade with Carrara marble tiles of the Opera Oslo House.

- to gain a deep insight into the causes of the discolouration (chromatic alteration);
- to assess the conservation condition of Carrara marble, with particular regard to the severe environmental conditions;
- to set-up tailor-made cleaning methodology of the marble tiles (Fig 1).

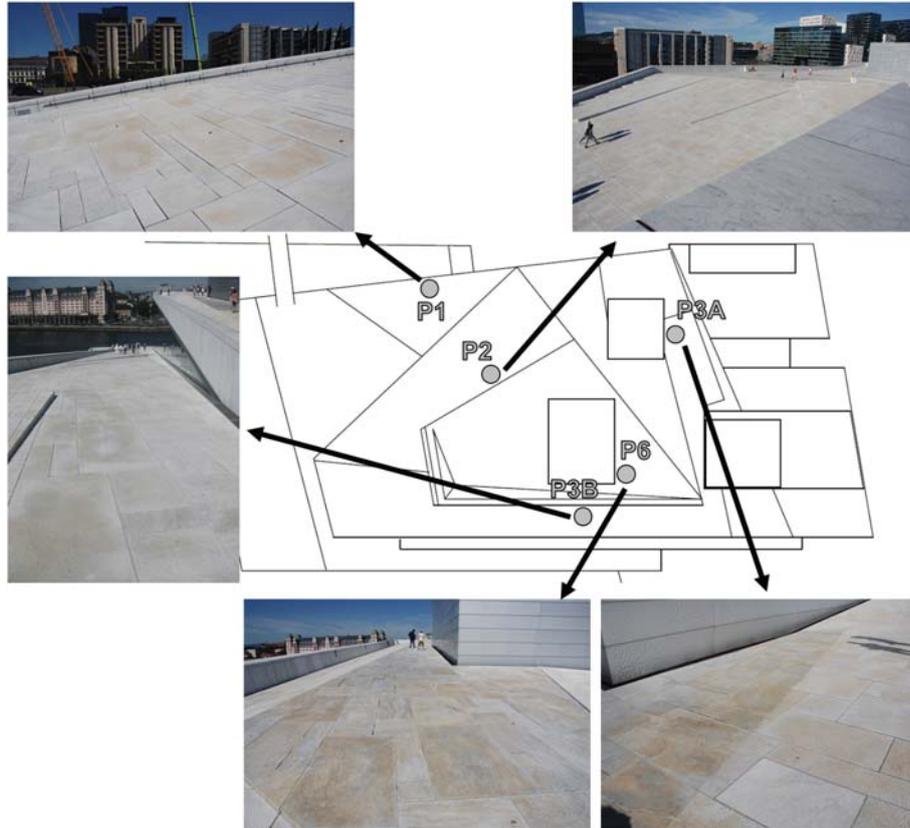
**Fig. 2.** Original localization of the marble tiles in the areas P1, P2, P3 and P6 of the building.

The Carrara marble tiles from OOH were demounted and collected from different areas of the building (P1, P2, P3A, P3B and P6), as reported in Fig. 2. In particular, from P1–P6 tiles several different small blocks were cut and sent to the laboratories in Italy and Greece.

The tiles coming from the building are characterized by different surface finishings: P1 tile has a “heavy bush hammered” finishing, P2 and P3B tiles have a “rough bush hammered” finishing and P3A and P6 tiles have a “sawn” finishing (Fig. 2) [2]. Some specimens, which were cut from the internal part of a Carrara marble tile “not exposed” (as referred from Statsbygg) on the roof of the building but conserved in the backyard at OOH, were considered as reference sample for the unaltered material. Moreover, reference products of the two surface coatings used for the protection of the marble,

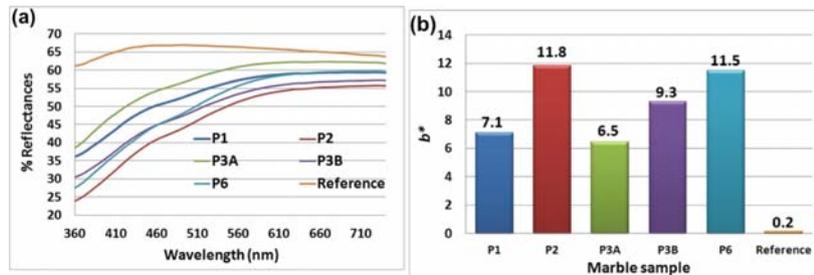
**Fig. 3.** (a) Reflectance spectra and (b)  $b^*$  values of the yellowed marble originating from all the levels (P1, P2, P3A, P3B and P6) in comparison with the reference Carrara marble.

Figure 3 shows the color parameters as obtained by colorimetric comparison between the yellowed and reference Carrara tiles. The color parameter  $b^*$ , related to the

yellowing, along with the total reflectance showed the highest diversification in the P6, P2 and P3B Carrara marble tiles comparing to the P1, P3A and reference marble.

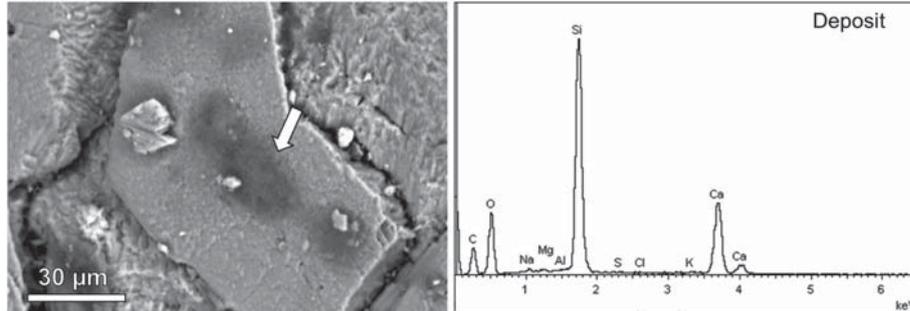
**Fig. 4.** Electron microscopic image of a crystal of P6 sample with accumulation of an organic treatment and the corresponding EDX spectrum.

The samples collected from the surface of P1–P6 tiles are characterized by a significant inter- and intra-granular decohesion, where the crystals show corroded gemination planes and detached grains near the surface. This important degradation phenomenon of the crystal structure is well described also in the document “ICOMOS-ISCS: Illustrated glossary on stone deterioration patterns” [4]. It can be related to changes in temperature due to severe microclimatic condition of the building, with freezing-thawing cycles, to surface erosion phenomena caused by the weather precipitations (rain and snow) and to salt crystallization cycles caused by NaCl (halite) marine spray and therefore cyclic dissolution and re-crystallization inside the surface porosity of the stone. In Fig. 4, the electron microscopy images of the surface of sample collected from P6 tile are reported. This sample is characterized by an intense yellowing with  $b^* = +11.5$ , and an inter-granular decohesion. In particular, the surface of some grains is characterized by the presence of some “drops” of an organic material (Fig. 4, darker areas) with high signals of Si and C, according to the elemental analysis, and ascribed to the presence of a siloxane treatment by means of solvent extraction and FTIR spectroscopy [5].

with the corresponding image of the yellowed sample in Fig. 4, and in the macroscopic images of Fig. 9 for the P3B. The cleaned P6 surface exhibited a grain detachment and etching along with a visible boundaries decohesion, but not to a greater extent than that observed for the yellowed counterparts.

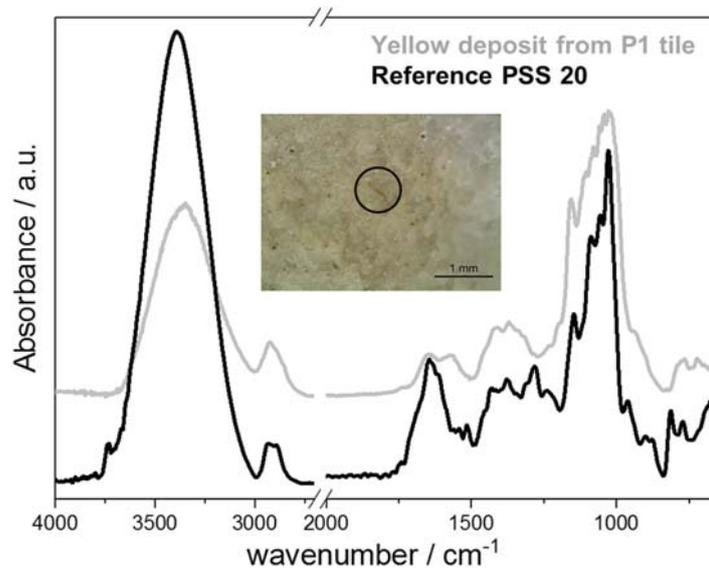
**Fig. 5.** Microscopic image of yellow-brown surface deposit on P1 tile with the FTIR spectrum of the deposit (grey) and the spectrum of the vegetable polysaccharide-based treatment (PSS 20) (black). (Color figure online)

In addition to the solvent extractions, the deposits observed on the surface of the tiles were collected and analyzed by FTIR spectroscopy equipped with an optical microscope to analyze sample at the micron scale. The spectrum obtained from one of these micro-samples is reported in Fig. 5, and compared to the spectrum of the anti-graffiti coating PSS 20, based on vegetal polysaccharides. A significant overlay of the absorption bands of the two spectra can be observed, in particular, the absorption bands at 3349 (OH stretching), 2926 (CH stretching), 1651 (OH bending), 1566 (C = O stretching in COO-), 1410 and 1365 (CH bending) and the main peak at  $1012\text{ cm}^{-1}$  related to C-C and C-O stretching of the pyranose ring of polysaccharides [6]. This result clearly indicates that these yellow-brown deposits are residuals of PSS 20 treatment.

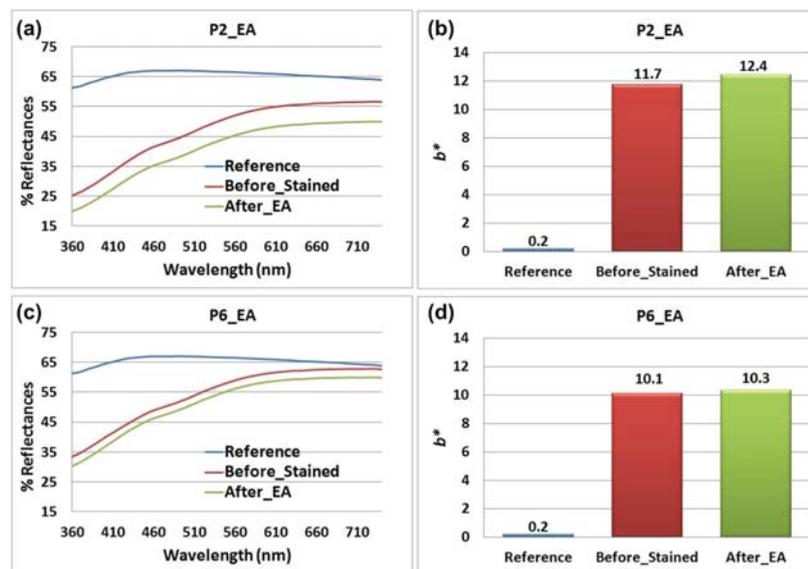
**Fig. 6.** (a) and (c) Reflectance spectra of the surfaces and (b) and (d)  $b^*$  parameter values of P2 and P6 marbles before and after the immersion in ethyl acetate.

acetate, alcohols or mixtures of them. Unfortunately, these solvents are not only toxic and harmful to workers' health, but they might induce further migration of the dissolved polymer inside the stone. Moreover, when solvents are used for the removal of the applied polymer, swelling of the polymer can be observed on the surfaces, thus demanding further mechanical abrasion in order the polymer removal to be completed. However, through this abrasion, especially in porous materials, parts of the material underneath could be disrupted. As expected, none of the colour parameters were improved and in almost all cases the spreading of the polymers inside the bulk of the marble resulted in a decrease of lightness and an increase of the yellowing parameter  $b^*$ , as illustrated in Fig. 6.

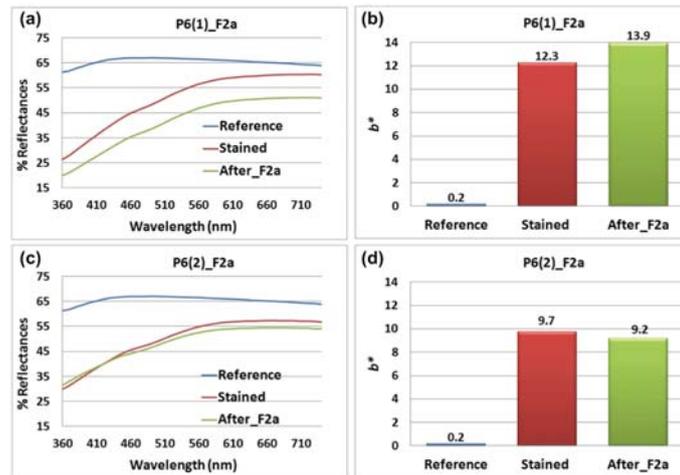
**Fig. 7.** P6 marble tile treated with NGEMS (F2a agent): (a and c) Reflectance spectra of the surfaces and (b and d)  $b^*$  parameter values before and after cleaning.

and the relevant formulations were designed in close collaboration with NanoPhos. However, no reproducibility characterized the application of these advanced cleaning systems and in some cases the state of the treated surface was clearly worsened (Fig. 7b).

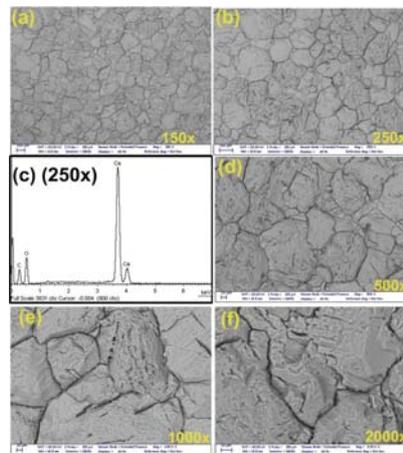
**Fig. 8.** SEM-EDX images of the cleaned P6 at different magnifications: (a) 150x, (b) 250x, (c) EDX spectrum (250x), (d) 500x, (e) 1000x and (f) 2000x.

Table 2 lists the changes induced after the three-step cleaning in the  $b^*$  colour parameter and the total colour difference  $\Delta E$ . The three - step cleaning methodology applied to P1–P3B marble tiles induced more than 50% change in the  $b^*$  parameter related to yellowness, while luminosity increased too. The P6 tile exhibited a 42% reduction of the yellowness and the highest total colour difference towards yellowed and reference sample. No morphological changes were observed after the three-step cleaning, as illustrated in the electron microscopy image of P6 tile in Fig. 8 comparing

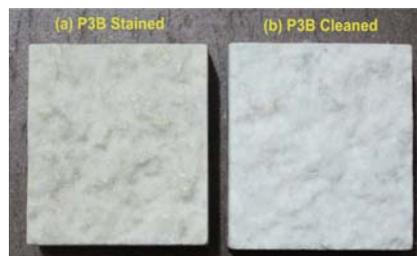
**Fig. 9.** Macroscopic images of the yellowed and cleaned surface for the P3B tile. (Color figure online)
