**Short desktop assessment of the farmstead situated on  
Portion 1 of the farm Bellevue 15321, Pietermaritzburg**

Prepared for:  
Archaeological Tourism & Resource Management  
PO Box 102532, Meerensee, KwaZulu-Natal 3901  
November 2010

## Introduction and methodology:

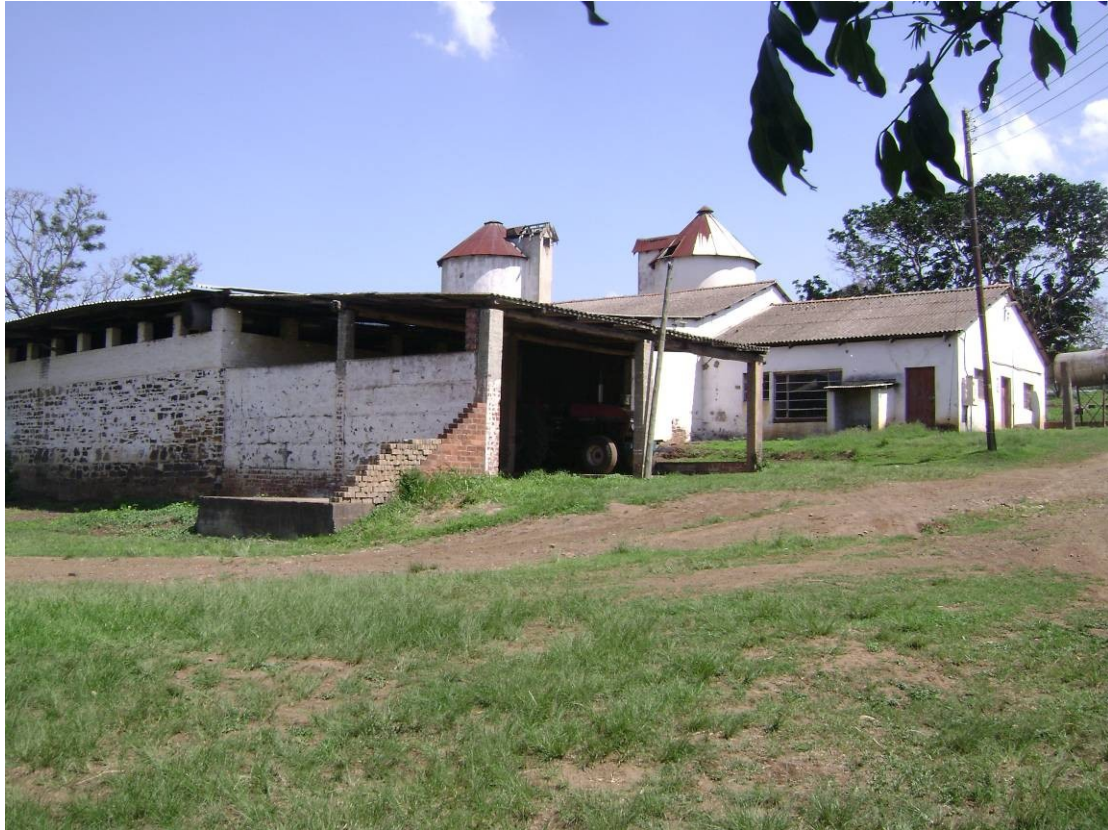
*Fig: Showing site from north (Author 2010)*

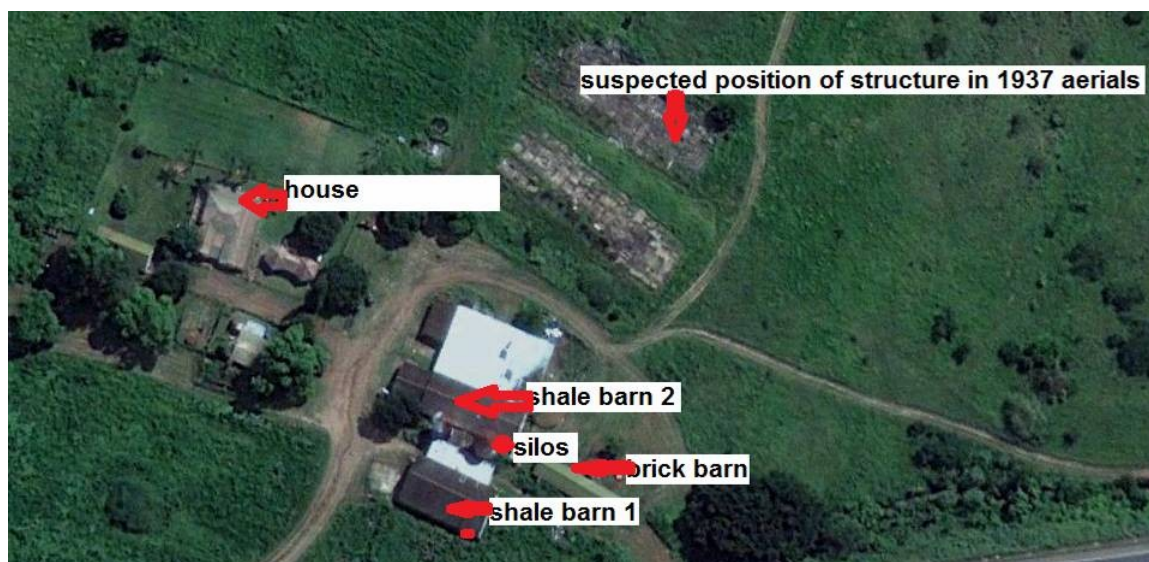
**Fig 1: Site layout showing buildings of concern**

Fig 1 above shows the site layout and the structures of concern. It is related to Fig 2 below, in that the latter is the aerial photograph from 1937 showing the farmstead as it stood then.
